**ARBORICULTURAL IMPACT  
ASSESSMENT REPORT**

**TRANSPORT ACCESS PROGRAM  
(TAP) 3**

**BEXLEY NORTH (RAILWAY) STATION  
KINGSGROVE AVENUE, BEXLEY NORTH**

**December 2018**

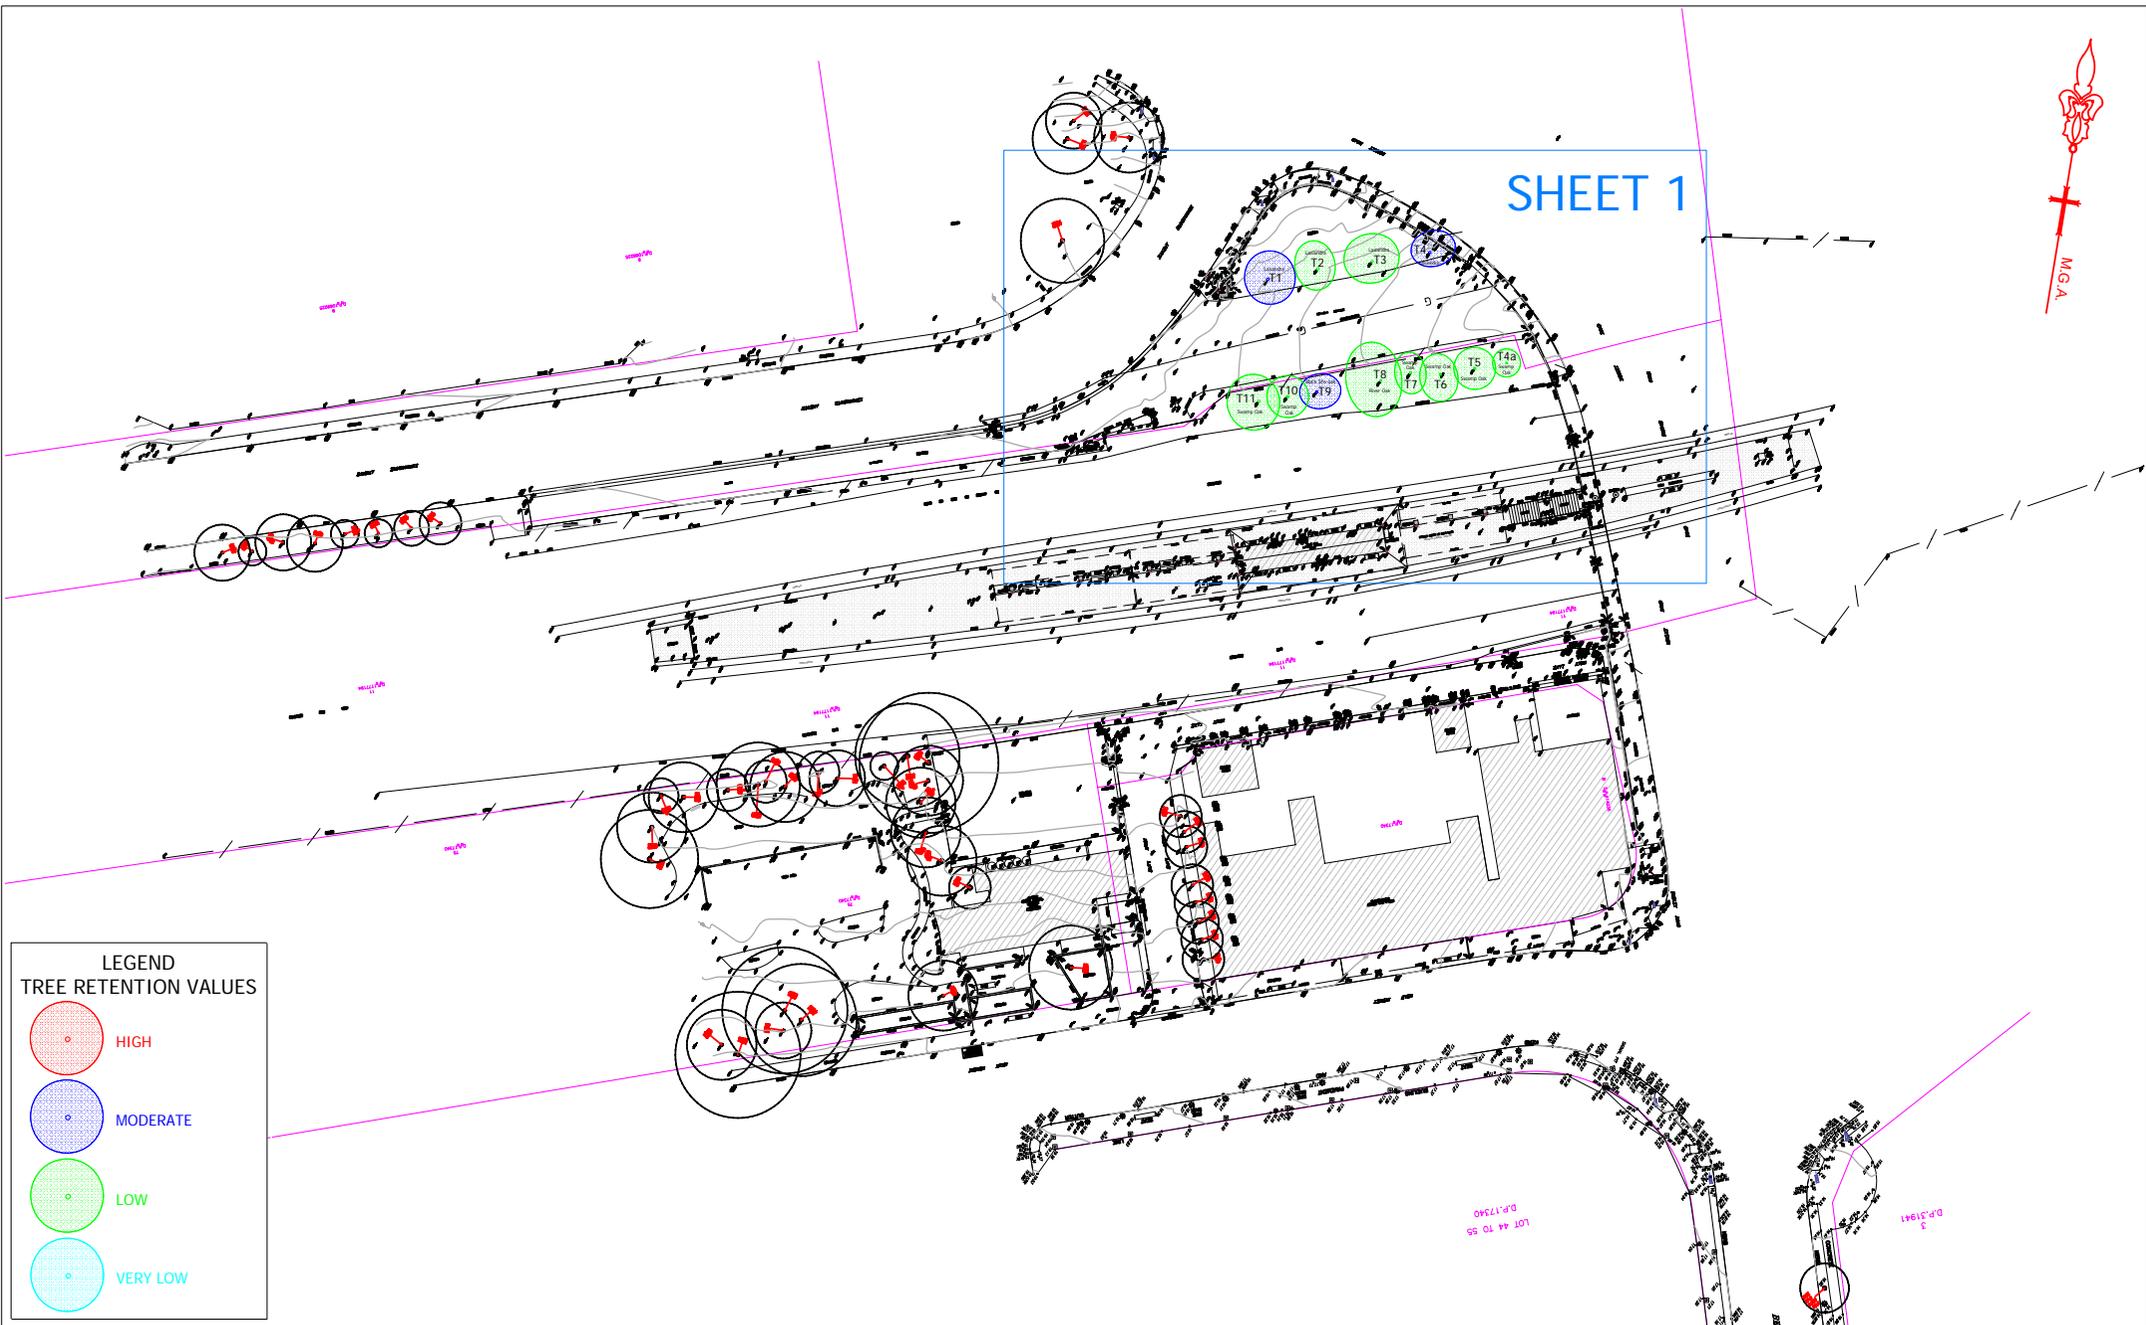
**APPENDIX 5**  
**TREE LOCATION PLAN SHOWING**  
**TREE RETENTION VALUES**  
 Bexley North Railway Station -  
 Bexley Road, BEXLEY NORTH

9.1.3 The proposed development will necessitate the removal of seven (7) trees of low retention value. These include Tree No.s T4a, T5, T6, T7, T10 & T11 (Swamp Oak) & T8 (River Oak). None of these trees are considered significant or worthy of special measures to ensure their preservation. The removal of these trees to accommodate the proposed development is therefore considered warranted in this instance. In order to compensate for loss of amenity resulting from the removal of these trees to accommodate the proposed development, consideration should be given to replacement planting with new trees in accordance with TfNSW *Vegetation Offset Guideline* (2017) as detailed in **Section 11**.

9.1.4 The proposed development will also necessitate the removal of one (1) tree of moderate retention value, being T9 (Black She-oak). This tree is not considered significant, but is in good health and condition and makes a fair contribution to the amenity of the site and streetscape area. In order to compensate for loss of amenity resulting from the removal of this tree to accommodate the proposed development, consideration should be given to replacement planting with new trees in accordance with TfNSW *Vegetation Offset Guideline* (2017) as detailed in **Section 11**.
