ALLIED TREE
CONSULTANCY

Arboricultural Impact Assessment Report

For the project titled
Glenbrook Station Upgrade;
Transport Access Program 3
Glenbrook Station Upgrade, GLENBROOK, NSW

REFERENCE **D4010**

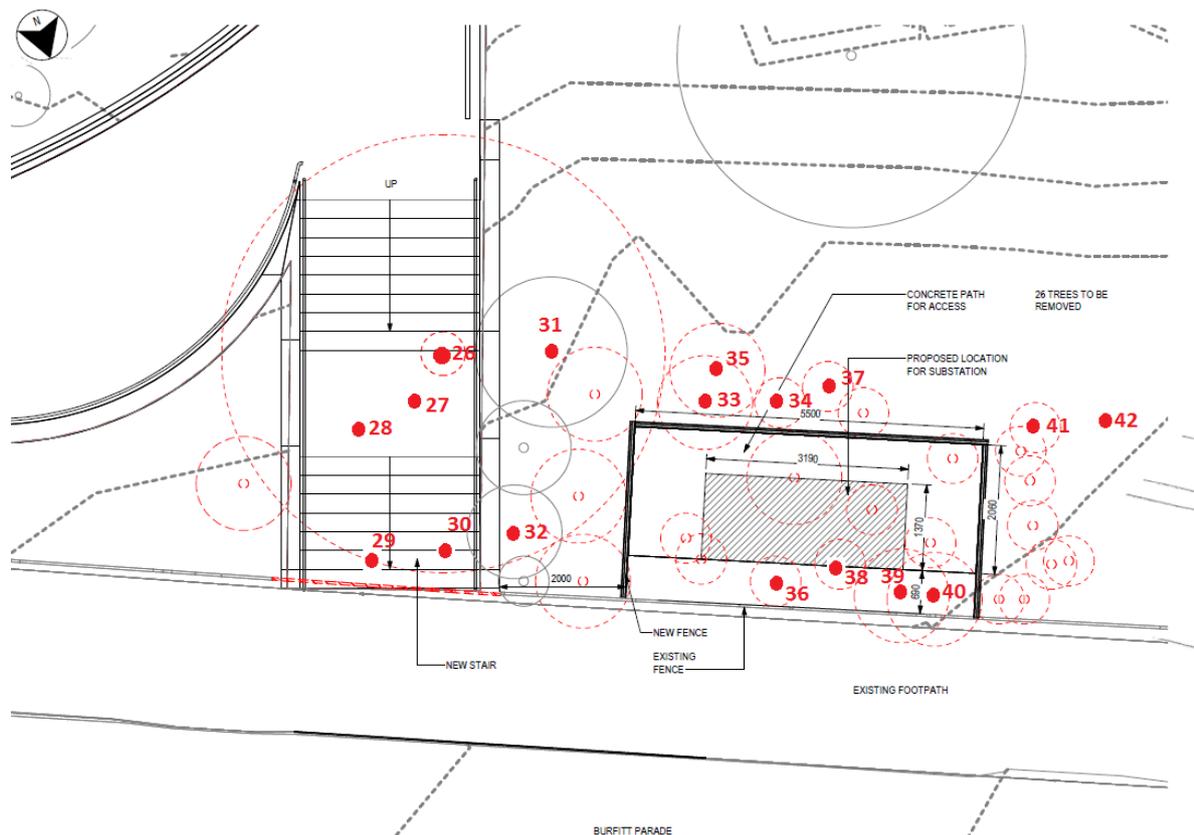
Figure 1; tree location relative to the transformer easement.

No drawings have been provided for the proposed route of sub-surface utilities. Any trenching, other than what has been allowed for should be avoided within the area of the TPZ's for any tree nominated for retention. Any proposed route shall be re-routed outside of the TPZ. Under boring may be required if a limitation for the route of a service is restricted to an that falls within the TPZ from any tree. Any excavation in the area of a TPZ must be authorised and conditioned by the project arborist.
